*MASTER PLAN FOR THE RESTORATION
OF THE DIMMIT COUNTY COURTHOUSE*

Prepared By
Frank Architects, Inc.
Laredo, Texas
March 2000

DIMMIT COUNTY COURTHOUSE MASTER PLAN

CARRIZO SPRINGS, TEXAS

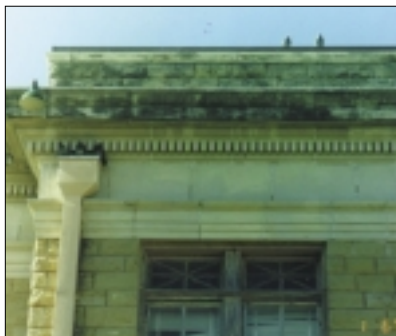
Problems with the roof of the courthouse have persisted throughout the years. The first mention of such problems occurred in 1940 when Dimmit County Commissioners Court minutes reveal the need for water proofing and repair of the cornice to ensure proper drainage. The minutes, however, do not reveal if the work was actually accomplished, as no mention of a contract was found. In 1959, repairs to the roof were conducted by a local contractor for \$1,710. The need for additional roof repairs became critical in 1976 with concern expressed for potential water damage to the carpeting in the courtroom.

East elevation

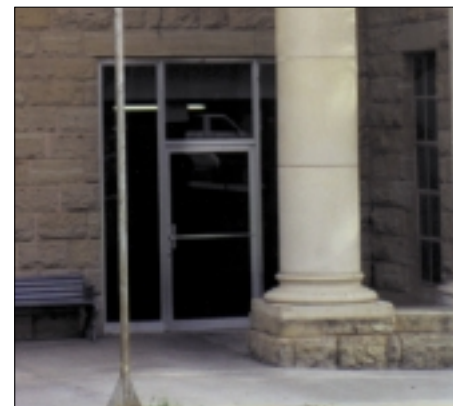
The exterior walls of the courthouse are constructed with limestone block. In general, the blocks appear to be in very good condition with the exception of two areas. Some minor discoloration of the blocks and deterioration of the joints are evident in the vicinity of the downspouts at the east wall (see above photograph of east elevation). This appears to have been caused by water overflow from the roof scuppers washing down the wall. In addition, there exists deterioration of portions of stone at the bottom of the west wall at the main entrance along the lower base courses. Water trapped against the wall and under the adjacent sidewalk have resulted in spalling and discoloration of the stone at this location. The existing tan mortar is deteriorating in some areas with considerable mortar damage around the courthouses cornice (see "Cast Stone Cornice", page 49).

Detail of front porch (west elevation)

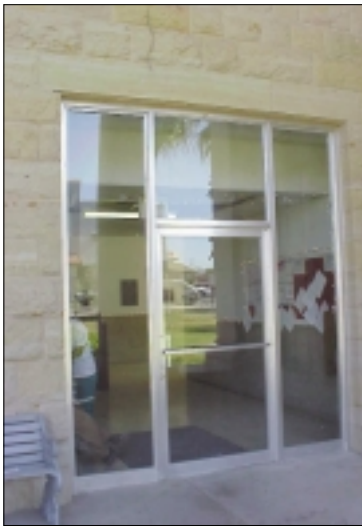
West door, main entry

There are three sets of exterior doors located on the north, south and west (main entry) facades of the courthouse. A single entry aluminum door capped with a fixed transom and flanked by sidelights is used on each of the three entries.

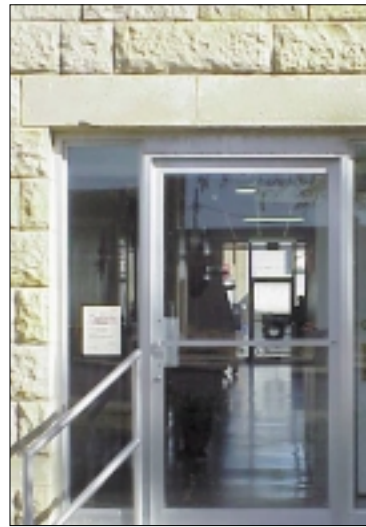
South door

The original wood doors were replaced by the present aluminum doors in 1960. Historic doors are depicted in surviving photographs of the north and south entries which indicate the existence of double wooden doors with inset glass flanked by sidelights with wooden kickplates.

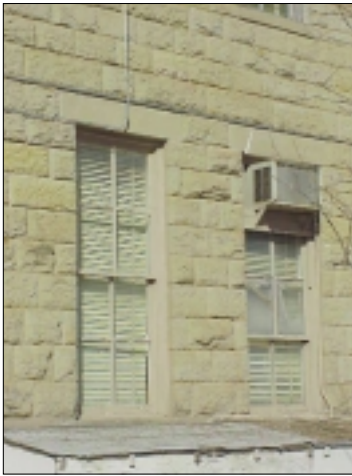
All of the windows need minor repairs, particularly the window casings and trim. Some rot and termite damage is evident in the interior frames, sills and trim, particularly on the ground floor windows. Windows located on the north and east facades are in good to fair condition and will require only sanding, refinishing and window adjustments. Windows located on the west facade are in fair condition with some minor damage. The south elevation windows have sustained the most extensive damage due to sun exposure. Approximately 20% of the windows are in need of new window frames, sash, and trim. New glazing is necessary for approximately 40% of all windows. Window hardware needs to be replaced for 80% of the windows, and weather stripping is required for approximately 90% of the windows. All windows are in need of sanding, refinishing, a primer and a finish of two coats of paint. Metal windows exhibit some rust. All windows have cast stone lintels, many of which are sagging and cracked.

Type A, east elevation

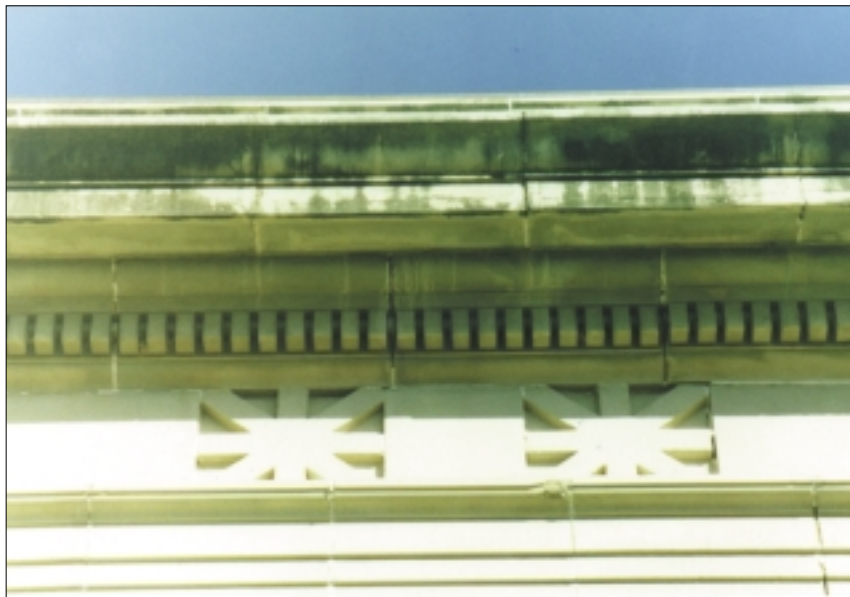
The courthouse features a deeply projecting cornice on all elevations. The stone of the cornice is in very good condition, but serious problems exist in the structuring of the cornice. In March of 1995, approximately thirty five linear feet of cornice fell from the south portion of the east wall. On the advice of the Texas Historical Commission, additional cornice pieces were loosened; this created a domino effect, resulting in additional molding shearing away from the building. These problems resulted in the erection of a steel framed structure adjacent to the north entrance and the closing of the south entrance to protect pedestrians from falling pieces of terra cotta cornice. The cornice was reassembled and attached in 1998. Further investigation of the cornice from the roof reveals that portions of the cornice along the east end of the south wall have rotated. In addition, it was observed that the mortar joints between cornice pieces are cracked. Please see the structural analysis report by WSC, Inc. (page 76) for additional information and analysis.

South elevation, east end of cornice

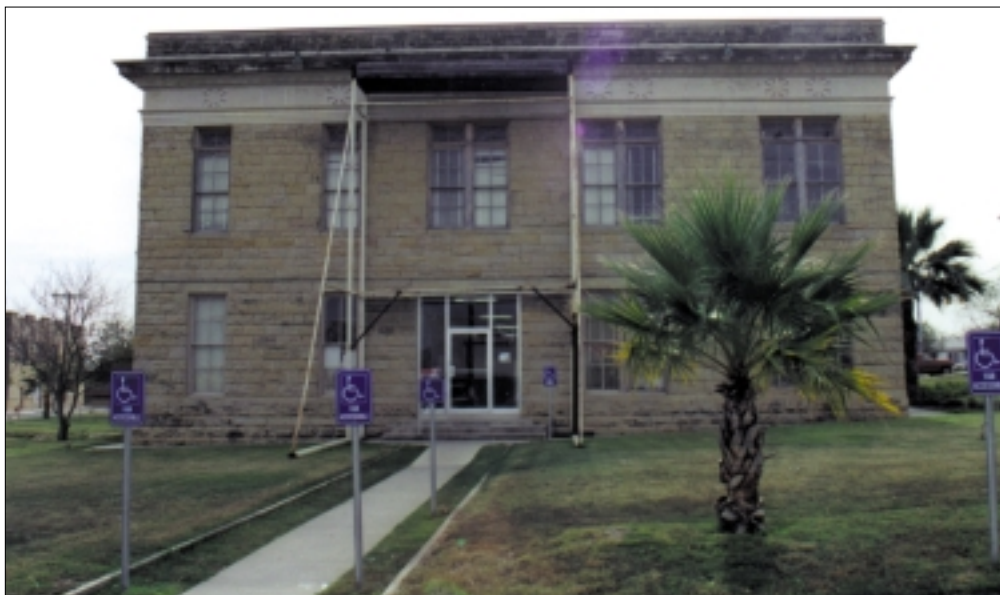
North elevation

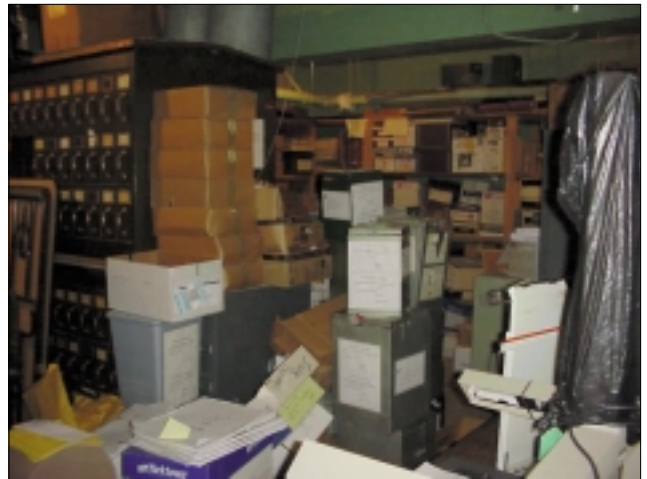
The west basement, located directly under the County Clerk's office (Room 116), is used to store County Clerk's records. Accessed from the County Clerk's office, it contains 150 square feet. There exists evidence of excessive moisture and sweating from exposed pipes which has affected the plaster walls and damaged some county records. These pipes appear to be wrapped with asbestos insulation.

West basement

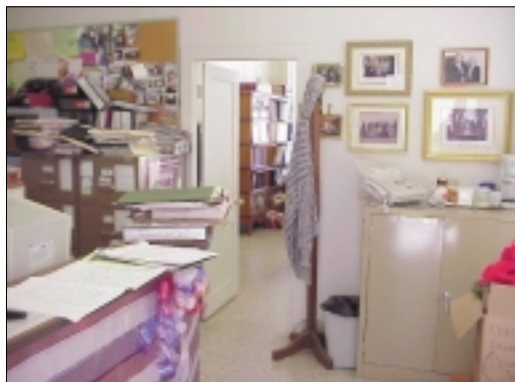
Looking into judge's office, Room 101

Windows, especially on the south elevation, are in bad condition (Window Type A) and present a serious security risk. The window sash is rotted from water infiltration and termite damage with the glazing in danger of falling out. The plaster walls are in poor condition with numerous cracks. Terrazzo flooring is non-historic (1960). An interior door leads directly from this office into the Commissioners Courtroom.

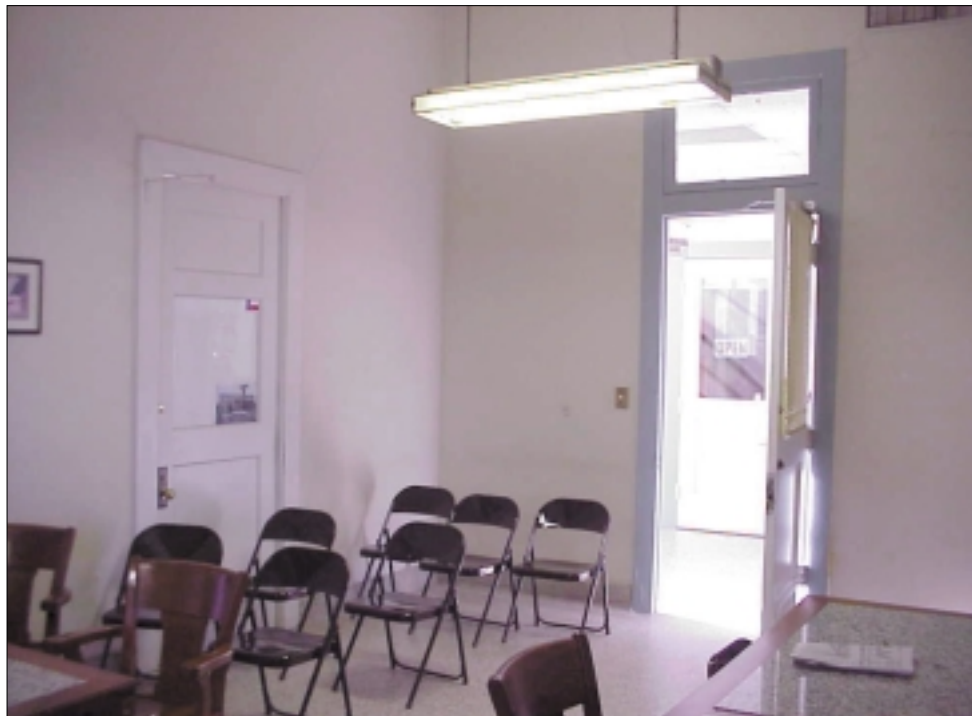
County Commissioners Courtroom, Room 102

The Commissioners Courtroom is accessed from the main hallway with an interior doorway leading directly into the County Judge's office. Containing only approximately 543 square feet, the room is inadequate for public meetings. A long table serves as a dais for commissioners with an additional table for county officials and a small desk for the county clerk. Seating for the public is limited to approximately twelve chairs which is wholly inadequate. The acoustics of the room make recording meetings very difficult. Plaster walls are in poor condition. The non-historic terrazzo floor was added in 1960. A tall bookcase on the south wall dates from the 1884 original courthouse and is one of the few remaining pieces of furniture from this period.

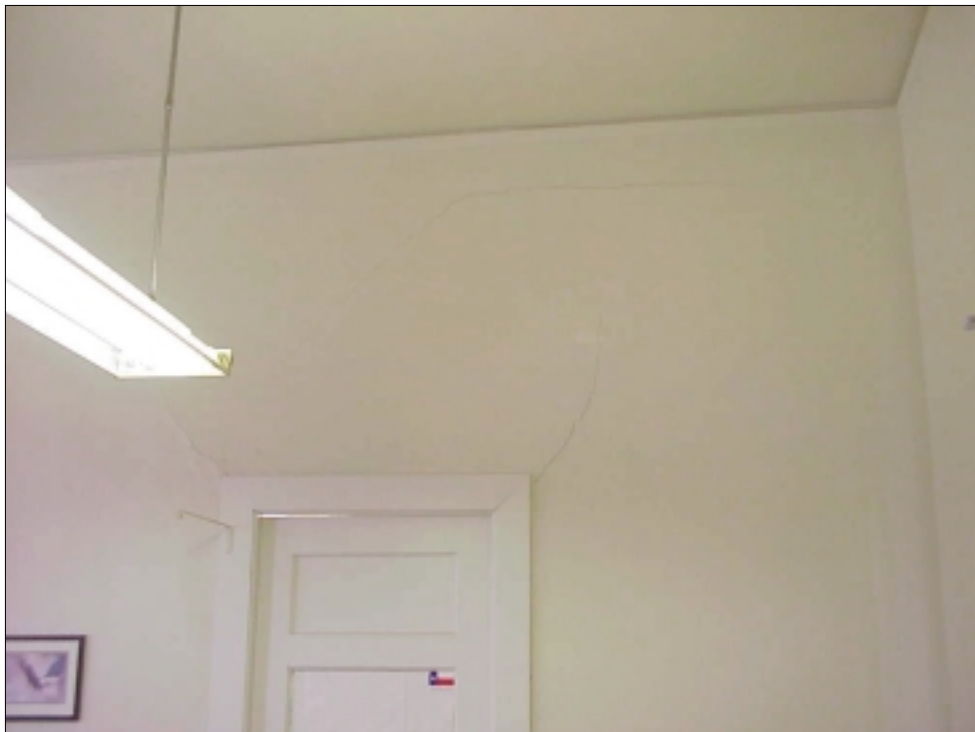
Cracked plaster, Room 102

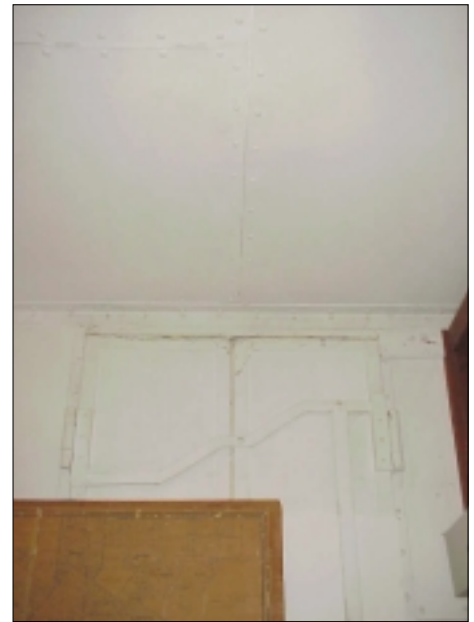
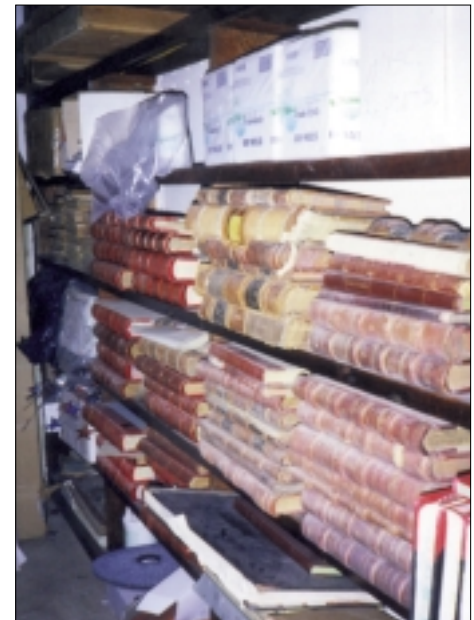
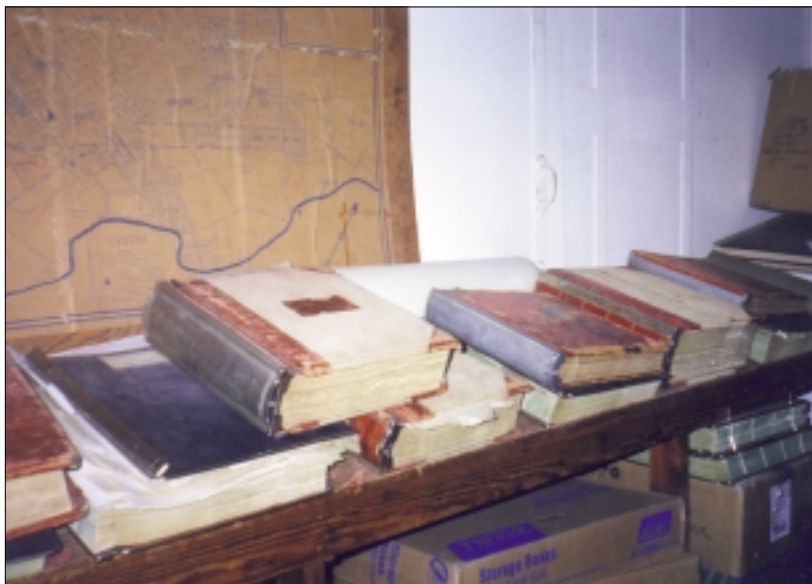
Detail of county vault door, Room 103

This vault, originally constructed for the 1884 courthouse, is accessed only through the adjacent storage room. Containing approximately 96 square feet, storage shelves contain most of the earliest deed records for the county. The vault is an important feature from the original construction period and is in good condition, although its small size is inadequate for today's record storage needs.

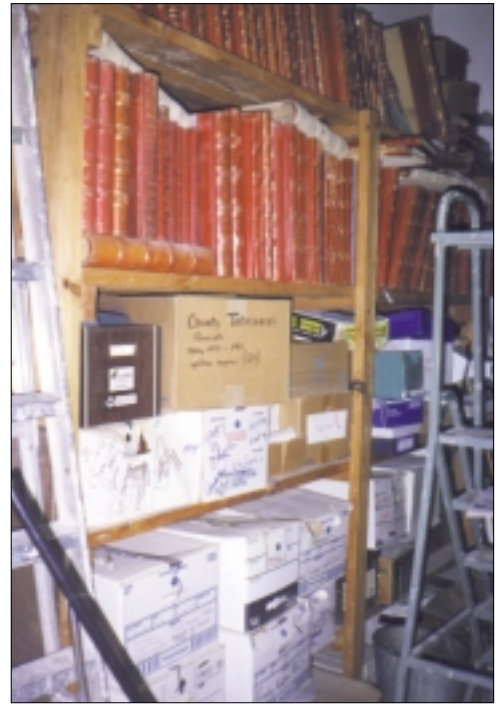
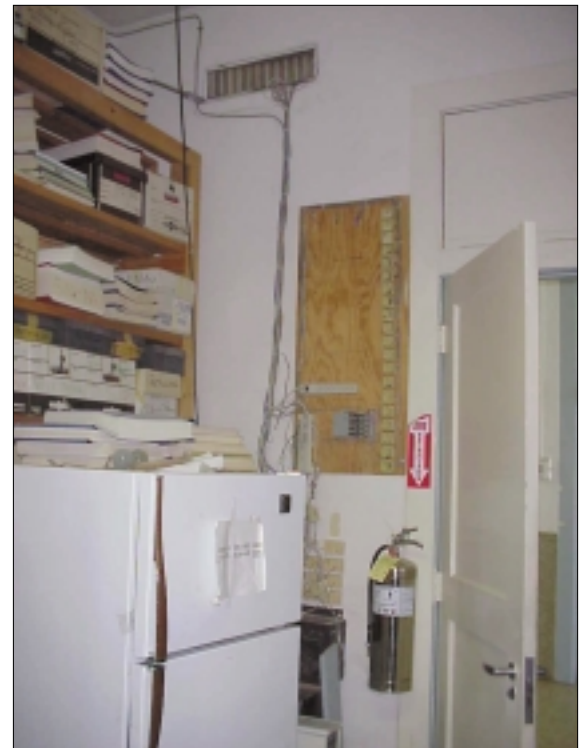
Detail of storage, Room 104

This storage area is accessed both from the main corridor and the adjacent Justice of the Peace's office. It originally served as an office and contains approximately 169 square feet. Three walls are covered with wood storage shelving extending the entire height of the sixteen foot ceiling, making it both difficult and dangerous to access records stored on the top shelves. The main telephone switchboard is located within this room. In addition to record storage, the room contains cleaning supplies and an old, but functioning, refrigerator which could present a fire hazard to the records.

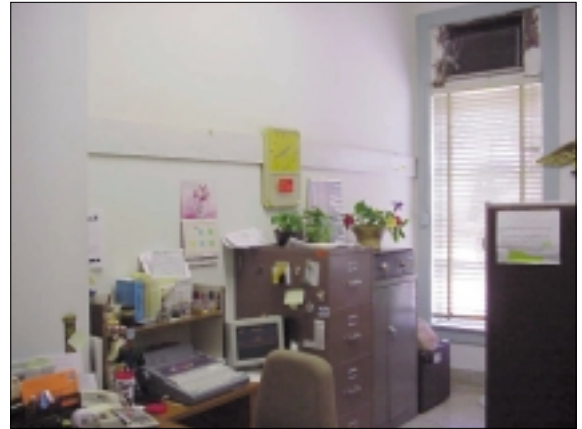
Justice of the Peace Offices for Precincts One, Two and Six, Room 105

Accessed from the main corridor, this office contains 221 square feet. An interior doorway leads directly into the adjacent storage room. This room serves as the Justice of the Peace Courtroom, as well as office space (one Justice of the Peace serves three precincts: Precincts One, Two and Six). Attorneys, defendants and witnesses must wait in the hallway outside, as the office lacks adequate seating or other facilities for holding court. Plaster walls are heavily damaged from water infiltration on the east wall.

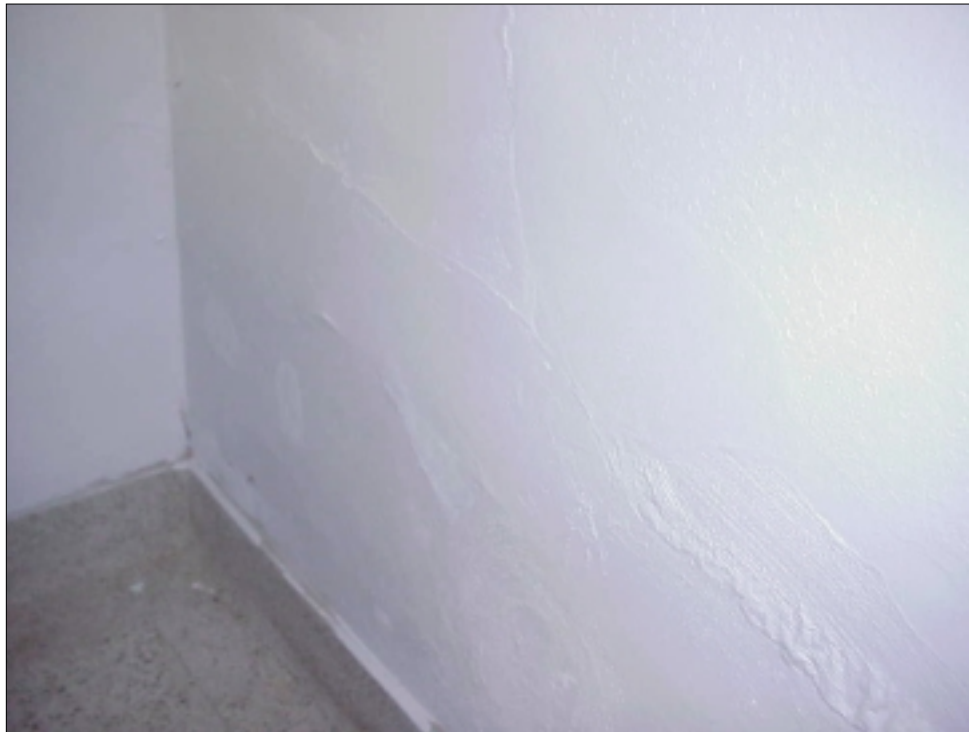
Detail of damaged plaster, Room 105

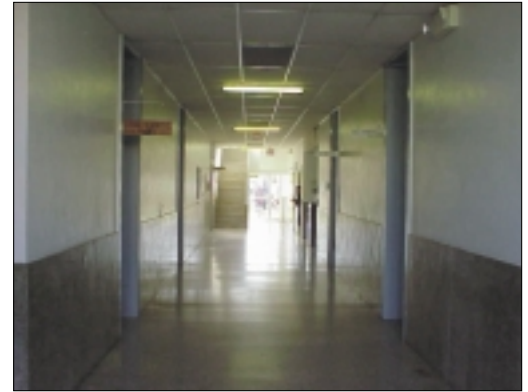
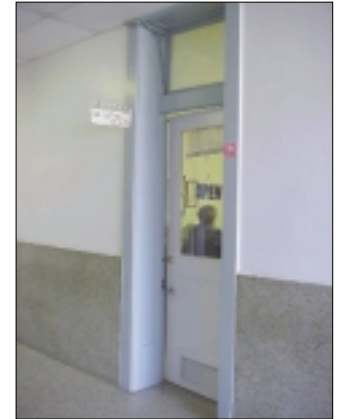
View of corridor, Room 108

This main corridor, which connects the north and south secondary entrances, serves as the main access point for offices on the ground floor. The original 16 foot ceiling has been dropped along the corridor and is now covered with acoustical tile, concealing the crown moulding. This dropped ceiling affects the strong axial procession along this main corridor. The terrazzo floor and wainscot are non-historic and were added in 1960. The plaster walls are in fair condition with some cracks. The damage may be extensive under the terrazzo wainscot.

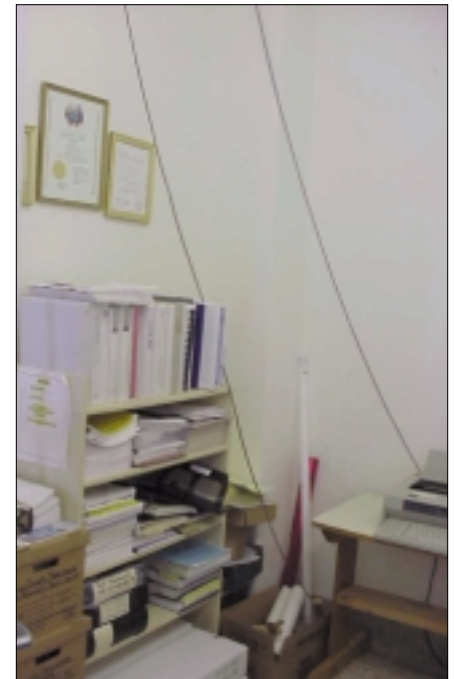
Detail of extension cords, through wall to adjacent room, Room 109

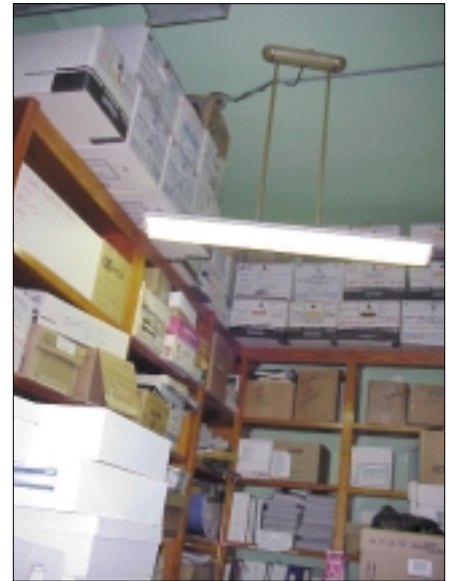
View into storage, Room 110

This small storage space is approximately 72 square feet and contains shelving extending to the ceiling, making it difficult to access records. The walls are both plaster and gypsum wall board and are in fair condition with some cracking.

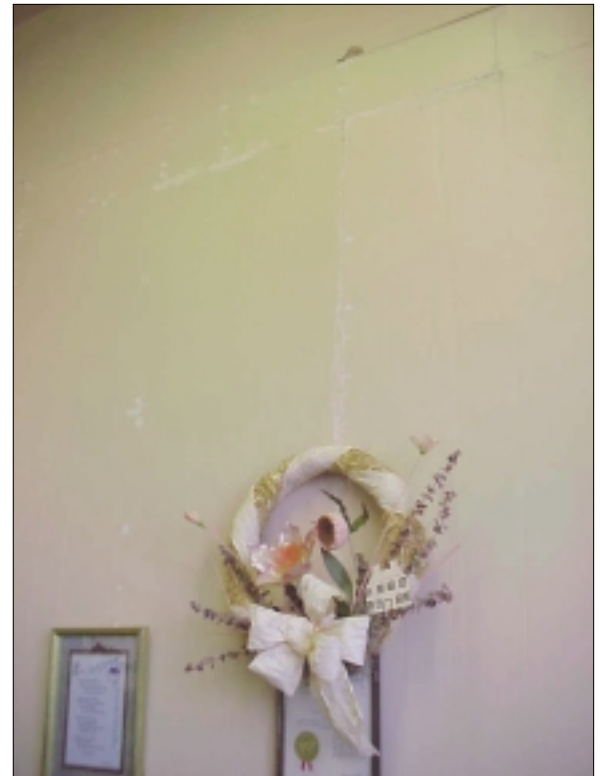
Originally a vault for the 1926 remodeling of the courthouse, this space now serves as a private office for the County Tax Assessor-Collector. The windows of this room are fixed metal casement with wire mesh reinforced glass, typical of the vault areas from the 1926 remodeling. The windows along the west wall are covered from the interior, but neither the window opening nor the metal sash are affected. Severe cracks in the plaster wall are evident along the east wall and all of the walls are in poor condition. The original steel door of the vault is extant and should be retained.

Cracked plaster, Room 111

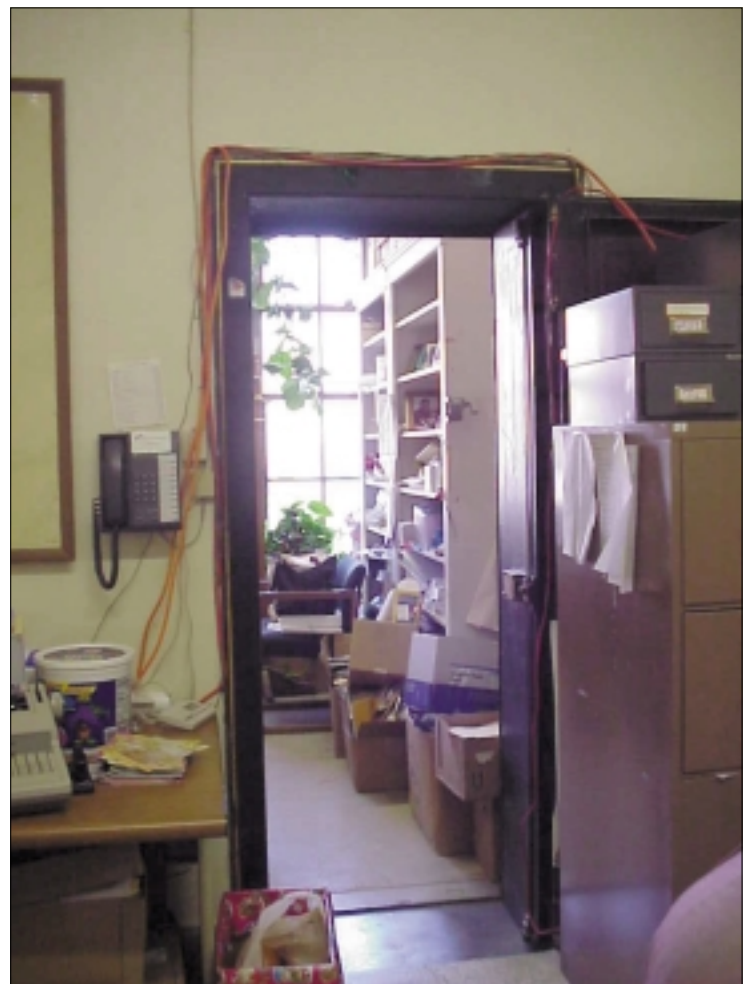
Detail of computer wiring, Room 112

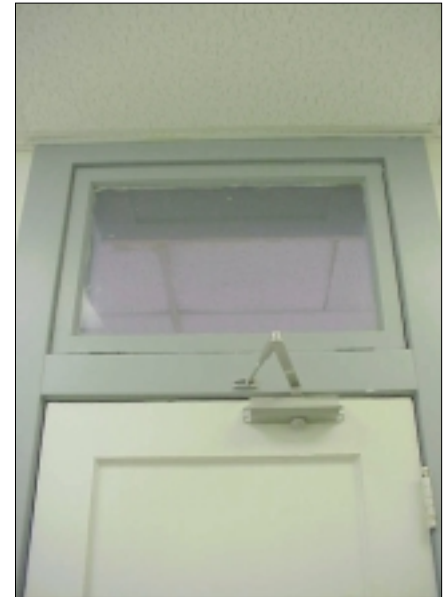
Detail of door, men's restroom, Room 113

The plaster walls are in good condition. Gypsum wall forms the west wall. The door appears to date from the original installation of this restroom in either 1909 or 1911. All walls are in good condition. Containing 65 square feet, this restroom facility was recently upgraded to meet ADA requirements. This is the only men's restroom serving the ground floor and is located off the main corridor.

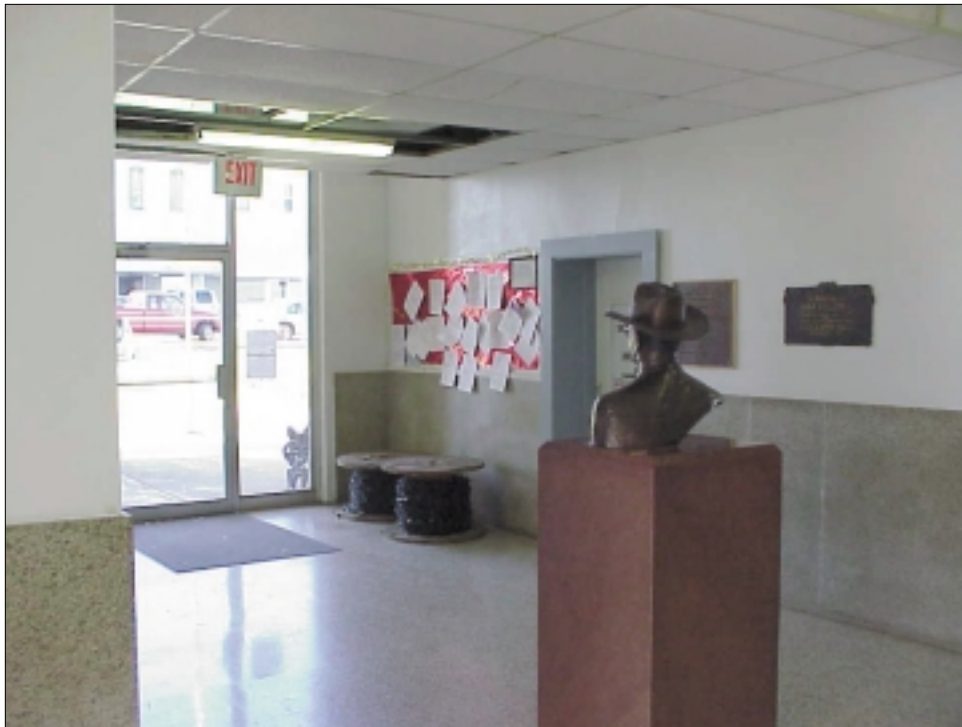
Entry Foyer, Room 115

The entry foyer serves as the ceremonial entrance to the courthouse and connects with the main corridor. Access is through a modern glass and aluminum door which is asymmetrically set on the front porch. The terrazzo floor and wainscot was added in 1960. The ceiling is dropped within the foyer with a suspended acoustical tile ceiling. The heat pump air handler is located above the corridor ceiling in the foyer (see report by HMG and Associates, page 78, for additional information). Several memorial and commemorative plaques occupy the north and south walls of this space including: a bronze plaque "In Memory of Juan Villereal died Nov. 1, 1918 in France" on the north wall; a bronze plaque "In Memory of Clarence Lee Mobley died France October 19, 1918" on the south wall; and a plaque commemorating the placement of the bust of Sheriff Murray on the north wall. The bronze bust of Sheriff Murray is located in the center of the foyer on a wood pedestal.

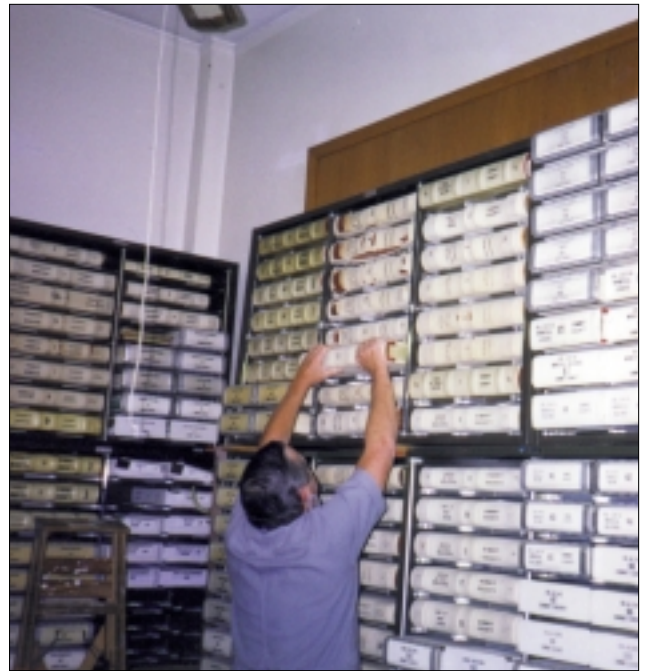
View to the southwest, County Clerk's Office, Room 116

This suite of offices includes approximately 786 square feet of space and is accessed from the main corridor at the south end of the building. This large, open space includes all deed records in shelving systems stacked approximately 10 feet in height. Two large work tables provide space for users of the records. The office also includes desks for two deputy clerks, a copier used by all offices on the ground floor and the mail center. A stair located near the center of the office suite leads to the west basement and serves as additional storage. An interior door leads to the private office of the County Clerk. The plaster walls are in good condition and the ceiling is composed of both the original plaster and a suspended ceiling over the eastern section of the room. The elevator shaft is located just to the north of the doorway. The windows located on the south and west walls are covered with wood paneling as shelving now covers all of the window openings. The windows maintain their original openings, but were unavailable for inspection from the interior. There is only one means of egress from the room which is generally crowded with people utilizing the records.

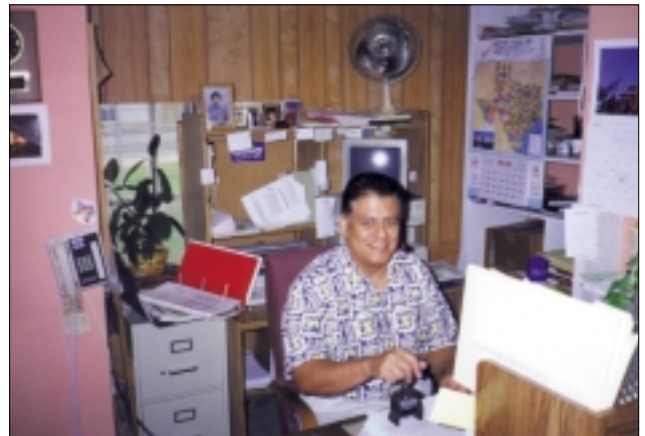
View into County Clerk's Private office, Room 117

This small office is accessible from the interior of the County Clerk's main office. The plaster walls are in good condition and a crown moulding is concealed behind the modern suspended ceiling. The office space is very cramped and is also used for storage of some records. The windows are covered with a wood paneling, primarily for environmental reasons.

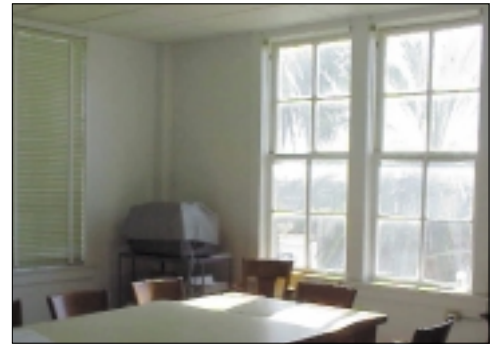
Jury Room, Room 201

Located at the end of a narrow corridor at the south end of the building adjacent to the Sheriff's office, the jury room is approximately 335 square feet. Two safes are located in the room for evidence storage by the Sheriff's Department. This room is located at the opposite end of the building from the District Courtroom, necessitating jurors walk along a public corridor before and during deliberations. The plaster walls are in fair condition with some water damage along the east wall. The original plaster ceiling is concealed by a dropped ceiling, but is in good condition. The windows are in bad condition. The jury table is reportedly the original table used by commissioners court.

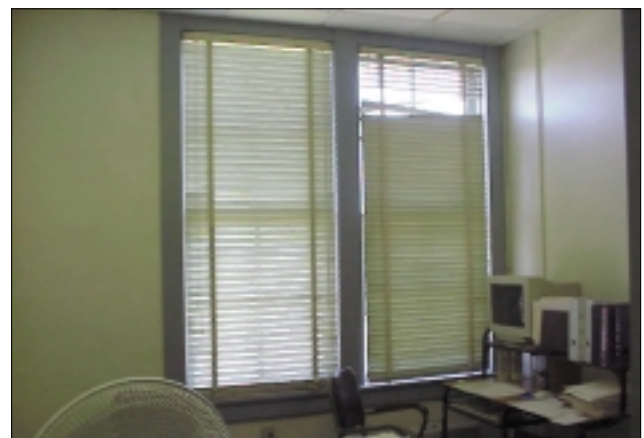
County Auditor's Office, Room 202

Located in the southeast section of the courthouse, this office is accessible only through the secretary's office and contains approximately 120 square feet. Plaster walls are in fair condition. Interior partition walls of gypsum wall board separate the auditor's office from the secretary's office and the jury room. The original moulding and ceiling are concealed behind the dropped ceiling. The windows are in bad condition.

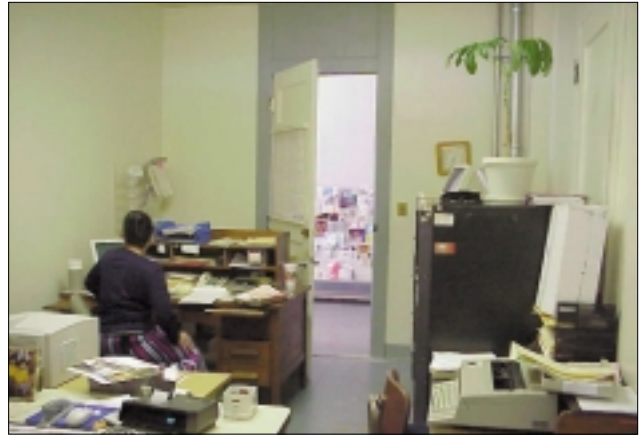
Office of County Auditor's Secretary, Room 203

This office is accessible from the main corridor and contains approximately 200 square feet. Two people occupy the space in addition to numerous files and records. The plaster walls are in fair condition.

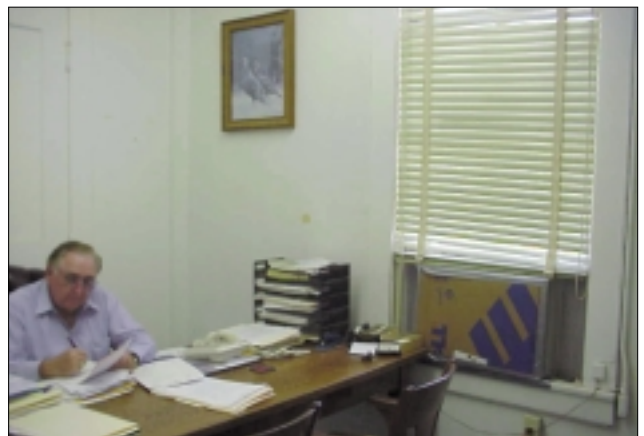
County Attorney's Office, Room 204

The County Attorney's Suite is located between the County Auditor's office and the District Courtroom. The County Attorney's private office, containing 125 square feet, is accessed only through his secretary's office. The plaster walls are in fair condition and the window is in bad condition.

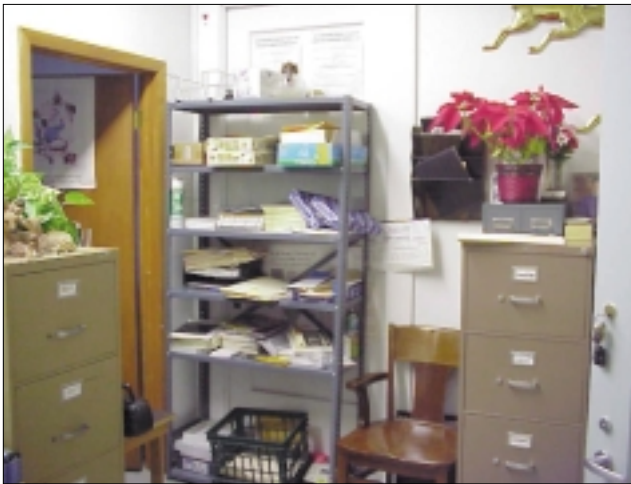
Office of County Attorney's Secretary, Room 205

Access to this office is from the main corridor, and it contains 125 square feet. Plaster walls are in fair condition.

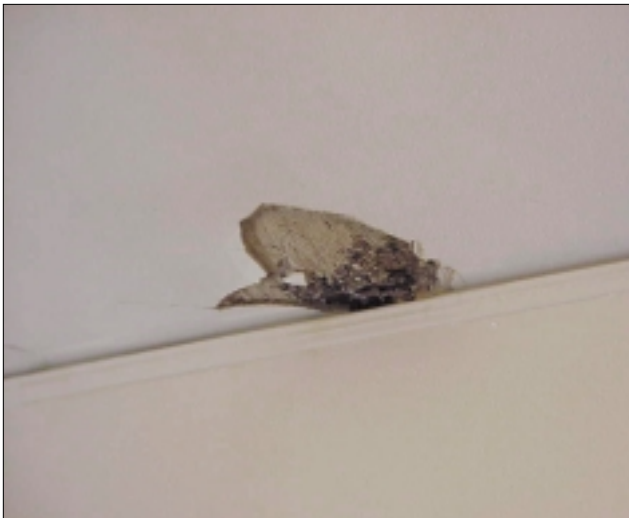
Ceiling damage in corridore, Room 206

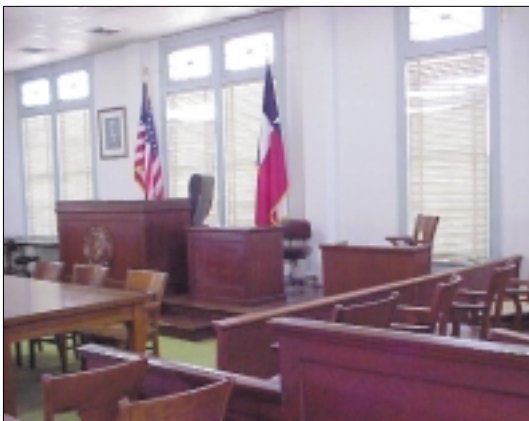
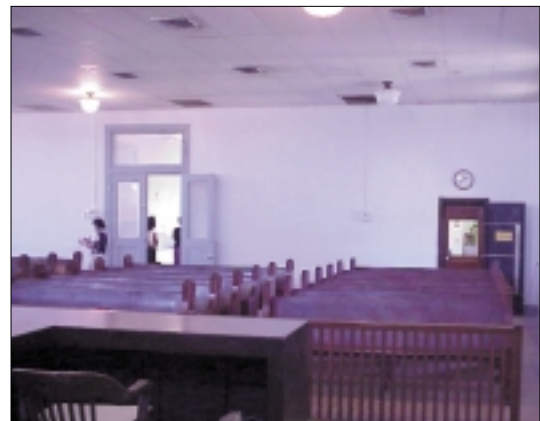
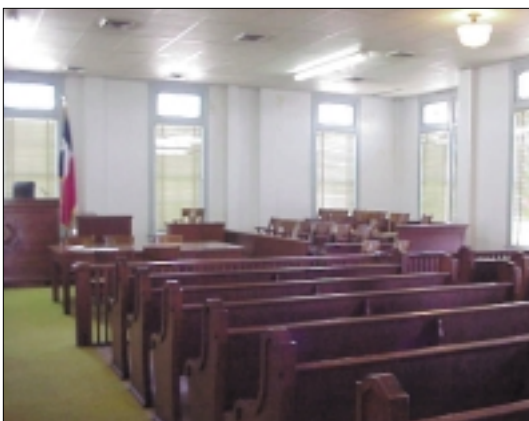
The District Courtroom is the focal space of the second floor and occupies the northern half of the building. It contains 2,525 square feet. Access to the District Judge's chambers and the law library are only through this space, creating a serious problem for egress from these interior rooms. The District Clerk's private office also has direct access to the courtroom. The original plaster ceiling is in good condition, but it is concealed under a modern suspended ceiling. Much of the original furnishing of the courtroom survives and should be retained. There is currently adequate space for observers, but the jury room is located down the hall at the other end of the building. The plaster walls are in fair condition. The windows are in bad condition along the east and north elevations.

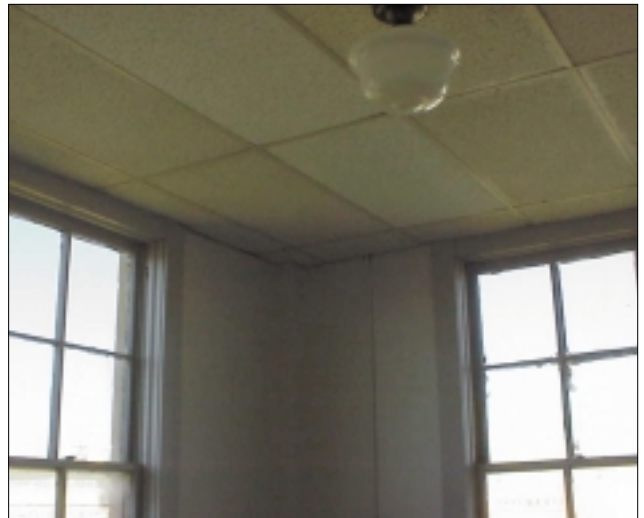
District Judge's Chambers, view to northeast, Room 208

The Judge's chambers occupy 180 square feet and are accessible only through the courtroom. The plaster walls are in good condition as are the windows.

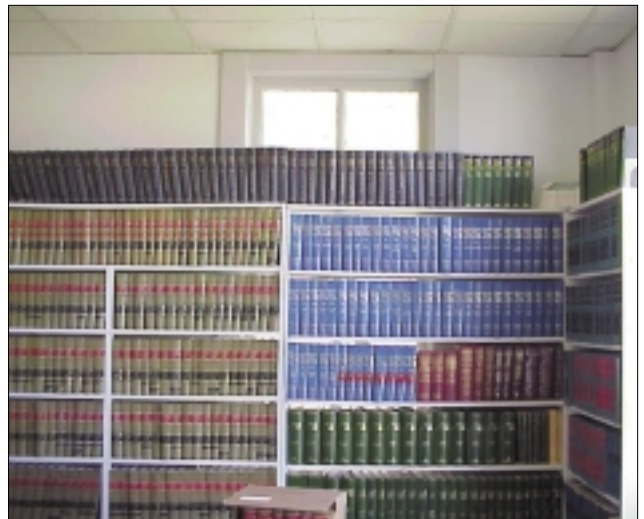
Law Library, Room 209

The law library, comprising 190 square feet, is accessible only through the District Courtroom. It is often used for conferences between attorneys and clients during court session. The plaster walls are in good condition. Book shelves are blocking the only window along the south elevation, preventing an adequate investigation of its condition.

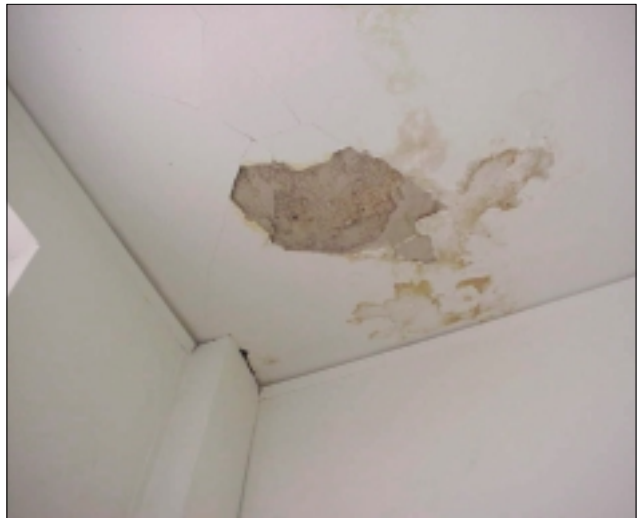
Damage to ceiling, District Clerk's Administrative Office, Room 210

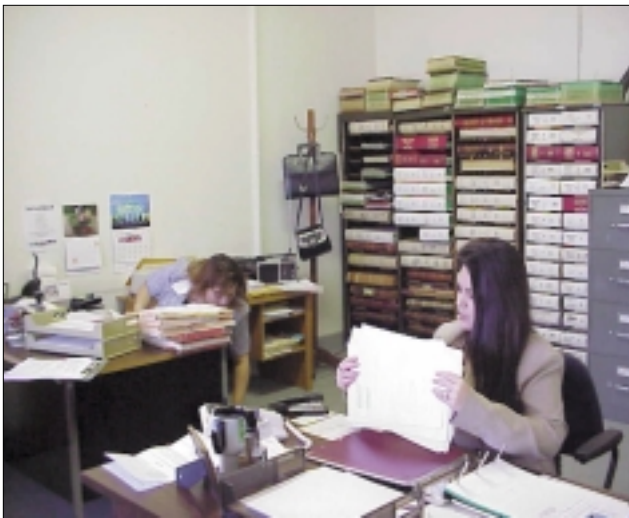
General view, Room 210

The office contains approximately 230 square feet and is accessible both from the District Courtroom and through the District Clerk's office. The plaster walls are in fair condition, as are the metal casement windows which overlook the porch of the main entry.

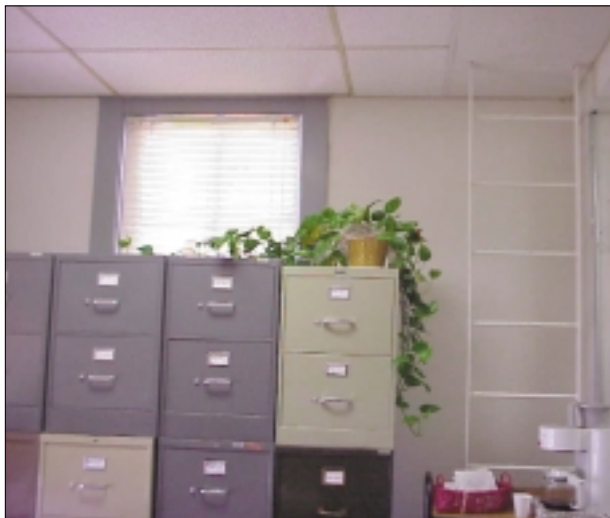
The office contains approximately 280 square feet and is accessible from a narrow corridor to the west of the main corridor. The office is a tangle of desks, filing cabinets, and boxes, many of which are stacked precariously. The windows along the north wall are blocked by filing cabinets and inaccessible to this observer. The windows along the west wall, however, are in good condition. The plaster walls are in fair condition with some cracking. The original plaster ceiling is concealed under a dropped ceiling. Access to the roof is through this office.

District Clerk's Office, detail of ladder into attic, Room 211

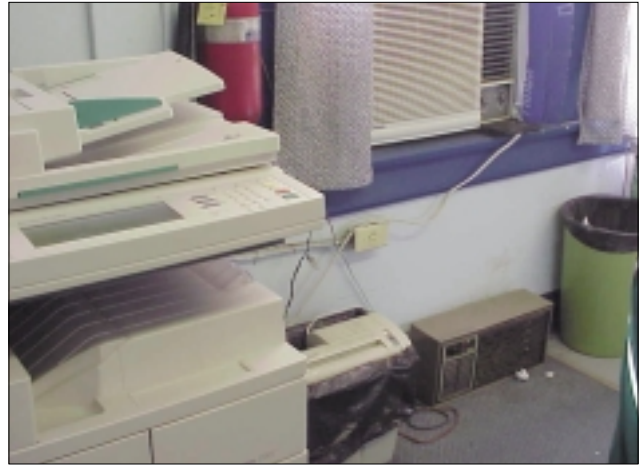
Detail of wiring in Sheriff's Dispatch Office, Room 212

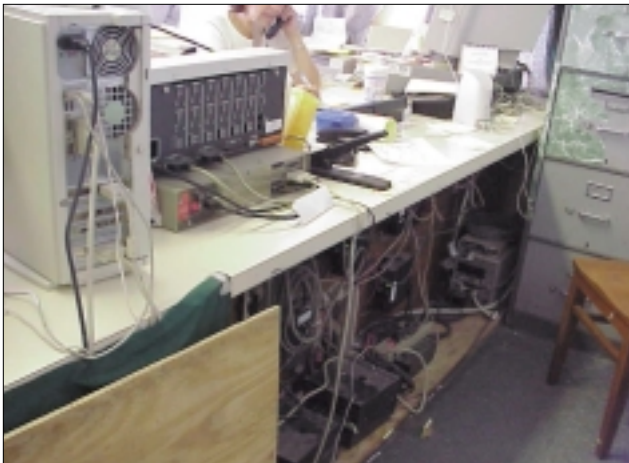
Detail of wiring in Room 212

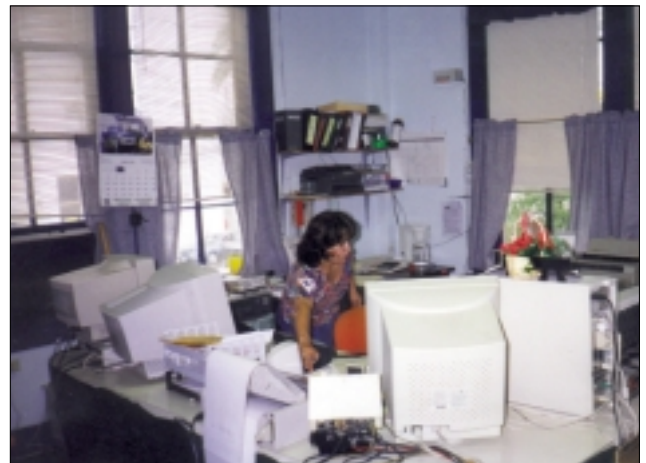
General view of Room 212

This room, containing 250 square feet (including the 911 equipment room), has a serious shortage of electrical outlets for the vast array of computer equipment necessary for the Sheriff's dispatchers and the 911 program. Personnel for this department includes five dispatchers and the room is much too small to adequately accommodate the office. The original plaster walls, located along the south and west, are in fair condition. An air conditioning unit is installed in the window along the south wall, which has caused some damage to the wood sash.

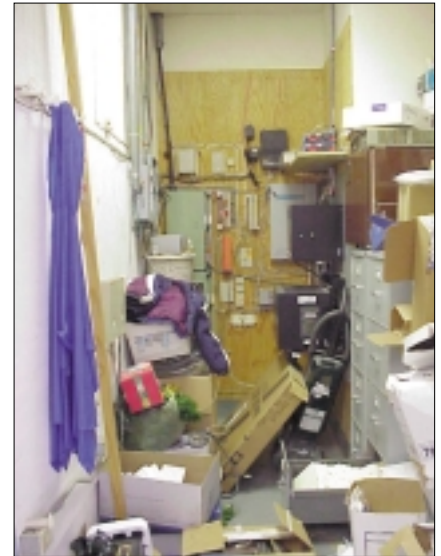
View into 911 mechanical and telephone room, Room 213

This small room, essentially a closet, plays an essential public safety role for the county, but is desperately inadequate for its purposes. This space contains all of the computer and recording equipment for the 911 system for Dimmit County. The plaster walls are in fair condition, but it was difficult to inspect due to the density of shelving within the space. The windows are covered with plywood along the south wall to prevent the sun from overheating the equipment contained within this small space. It was not possible to inspect this particular set of windows, but many of the windows along this elevation are in bad condition.
